## **Flexural Performance of RC Beams Repaired with Commercial Repair Materials**

**Abstract.** Different types of cementitious repair materials are commercially available in the local market. Almost all repair material suppliers claim that their products are most suitable for concrete repair under different environmental and loading conditions. This necessitates the need to check all aspects of the repair materials which include their behavior when used in structural elements. The objective of this research was to investigate the performance of the most commonly used cementitious repair materials when used to repair structural elements. This was achieved through the evaluation of the flexural performance of 24 RC beams repaired using nine selected types of the most commonly used repair materials (supplied by three leading suppliers in the country). The results were compared with two identical beams repaired with concrete and also with two identical beams cast with concrete monolithically (no repair). The results showed that the repair materials subjected to tensile stresses had no significant contribution (to beam response) compared to normal concrete. However, the influence of t

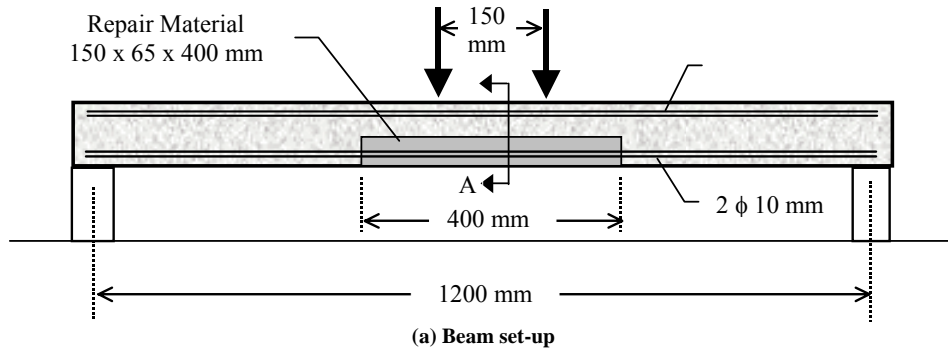
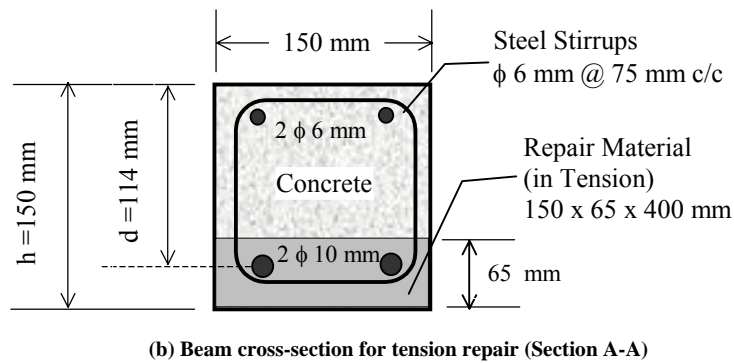
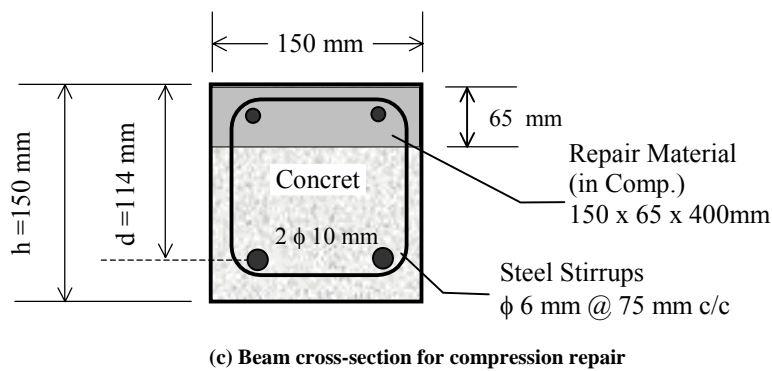
Fig. 1. The beam set-up and cross-sections for tension and compression repair.

The test span of all beams was 1200 mm with a cross section of 150 mm x 150 mm. All beams were reinforced with 2  $\phi$ 10 mm steel bars (main reinforcement) in tension side (bottom) of the beam, and 2 $\phi$  6 mm in the compression side (top) of the beam, and provided with  $\phi$ 6 mm steel stirrups @75 mm center to center. Details are shown in Fig. 1. All beams were tested simply supported subjected to two-point loads symmetrically placed at equal distances 75 mm from the centerline of the beam.

The beams were cast as shown in Fig. 1 in which a hole of 400 mm (length) by 65 mm (height) and 150 mm (width) was left open in each beam which represents the

damaged or deteriorated area that needs to be repaired using the repair materials. This hole was placed at the middle third region of the beam, having the highest moment. Similar dimensions of this opening were also used in the compression side (top) for the beams repaired in compression side.

The 28 beams (presented in Table 1) were tested simply supported subjected to two-point loads as shown in Fig. 1. The load-deflection relationships for the control (reference beam with no repair) specimens and for beams repaired with normal concrete are shown in Figs. 3 and 4, respectively. Three repair materials (M7, M8 and M9) were selected to present the load-deflection relationships for repaired specimens. Figures 5-7 show the load-deflection relationships for tension side repaired beams, whereas Figs. 8-10 show load-deflection relationships for compression side repaired beams. A summary

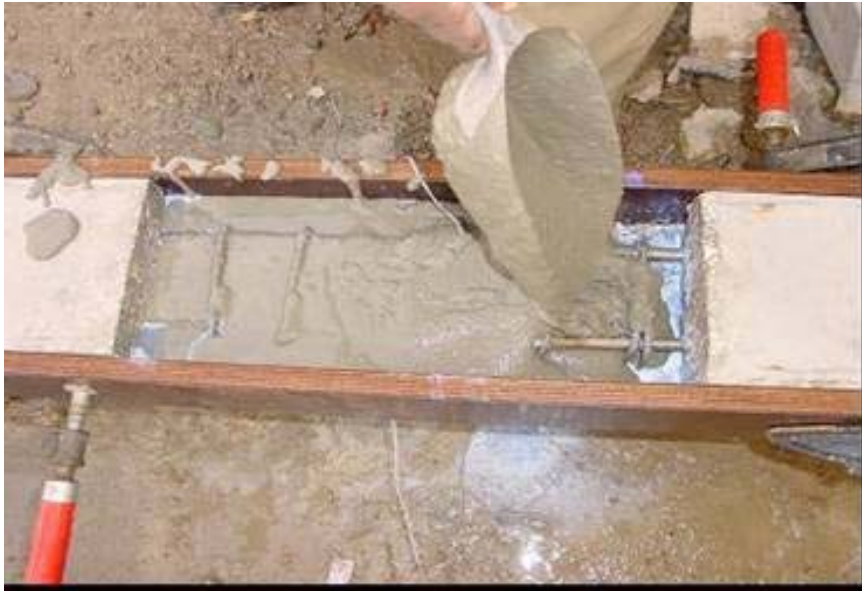
Fig. 2. Application of primer and repair material.

The beams to be repaired were first coated with the primers of the corresponding repair material. The mix was then poured into the properly enclosed pouring gap of the beam to be repaired by means of a scoop and the material was then tampered uniformly as shown in Fig. 2. After achieving the required filling, the repair material was smoothed-off on the surface by a trowel. Wet-burlap and plastic sheets were used to cover the beams to avoid any kind of moisture loss. The wooden enclosures of the repair section were demolded after 24 hours and the spray curing was started. The moist curing was continued for 28 days, and later the beams were tested.

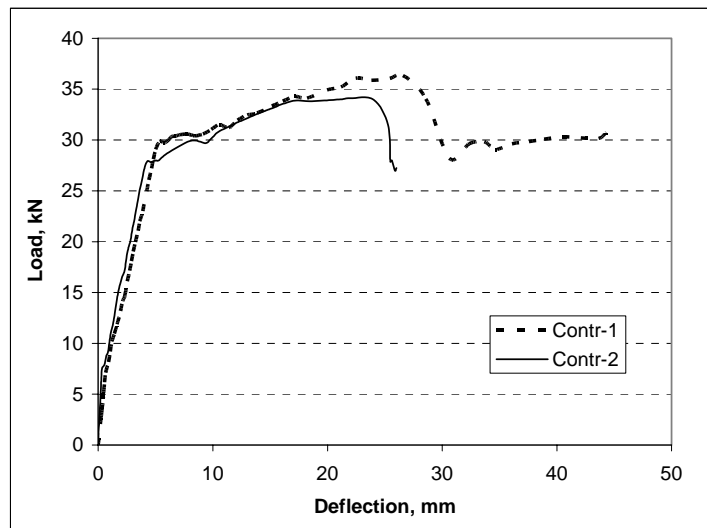
Fig. 3. Load versus deflection for the control (reference) specimens.

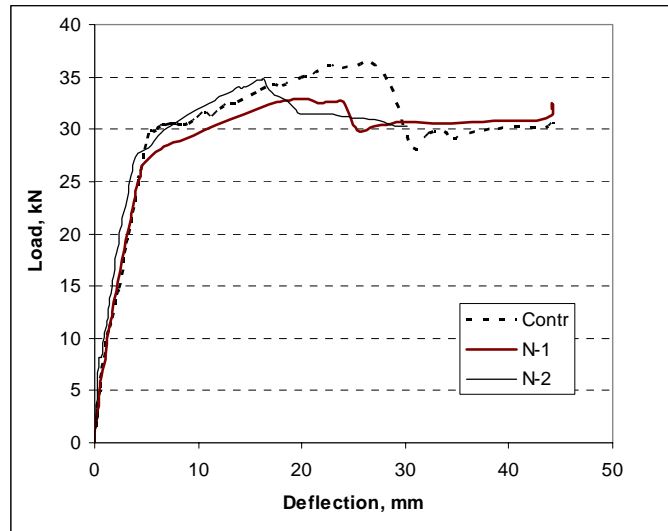
Fig. 4. Load versus deflection for control specimen (Contr) and specimens repaired with normal concrete (N).

The beams repaired with normal concrete (R-NC) in the tension side showed an average load capacity of 33.8 kN, with a change of only -4.0% of the original capacity of the reference beam.

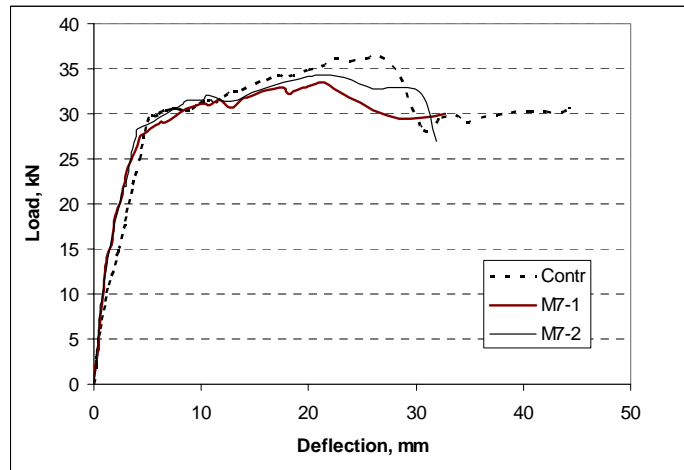
Fig. 5. Load versus deflection for the specimens repaired with material (M7) compared with the control specimen (Contr).

Furthermore, the load-deflection curves of beams repaired in the tension side (Figs. 5-7) showed initial stiffness almost similar to that of the reference beam. Also, the results show that there is no gain in the deformation capacity or ductility (defined as the area under the load-deflection curve).

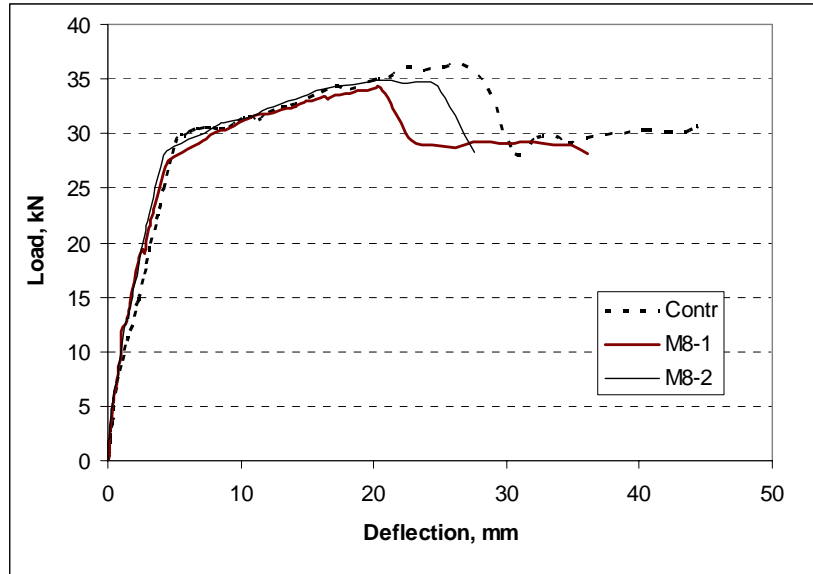
Fig. 6. Load versus deflection for the specimens repaired with material (M8) compared with the control specimen (Contr).

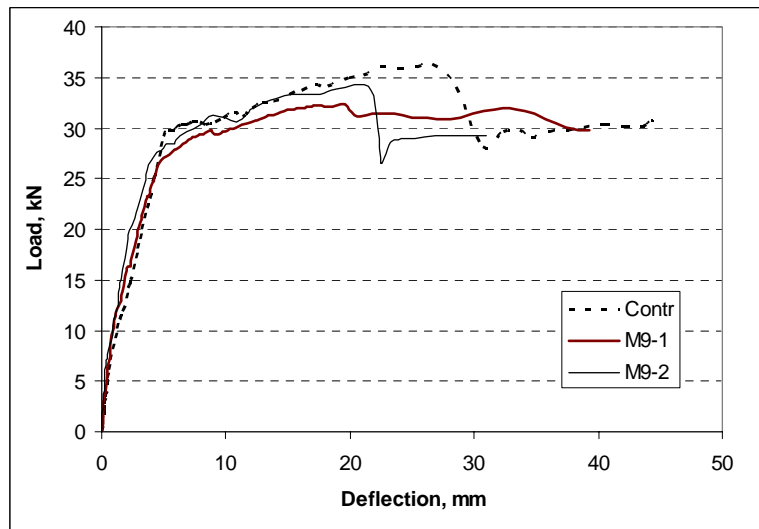
Fig. 7. Load versus deflection for control specimen (Contr) and specimens repaired with material (M9).

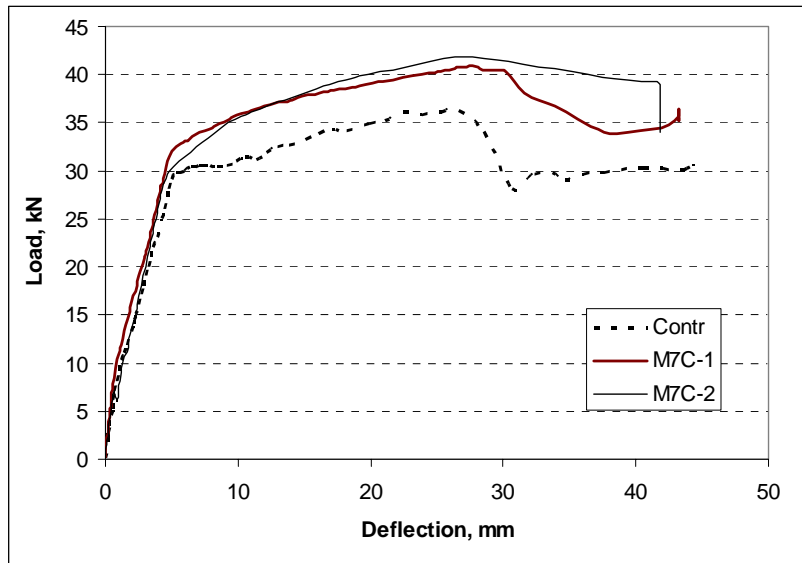
Fig. 8. Load versus deflection for control specimen (Contr) and specimens repaired (in the compression side) with material (M7).

Furthermore, the load-deflection curves of beams repaired in compression side (Figs. 8-10) showed initial stiffness almost the same as that of the control beam. However, the deformation capacity (ductility) of such repaired beams is substantially higher than that of the reference beam.

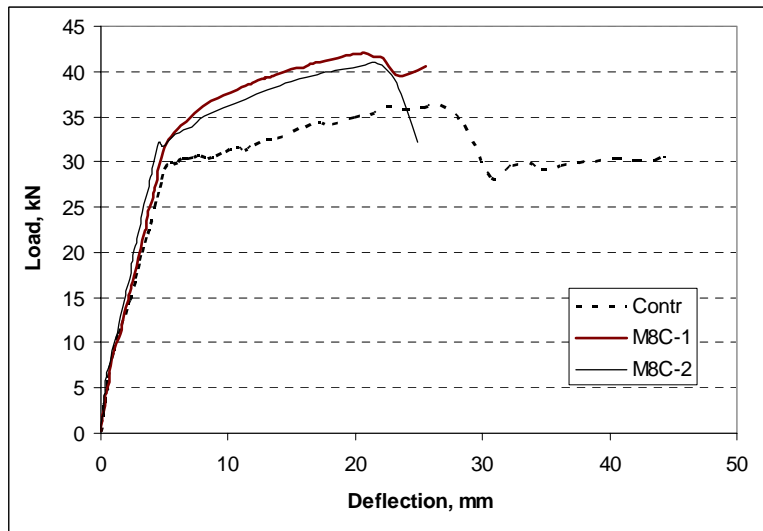
Fig. 9. Load versus deflection for control specimen (Contr) and specimens repaired (in the compression side) with material (M8).

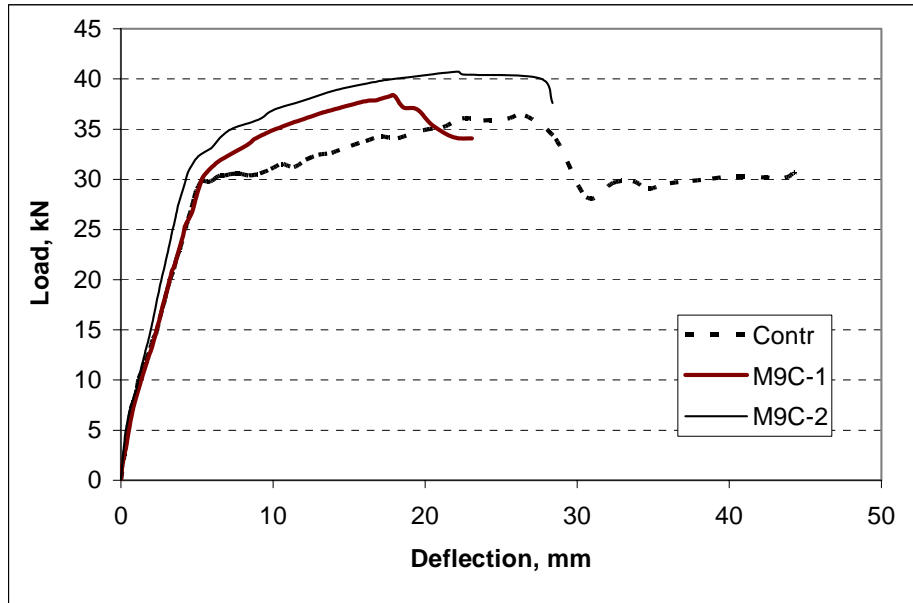
Fig. 10. Load versus deflection for control specimen (Contr) and specimens repaired (in the compression side) with material (M9).

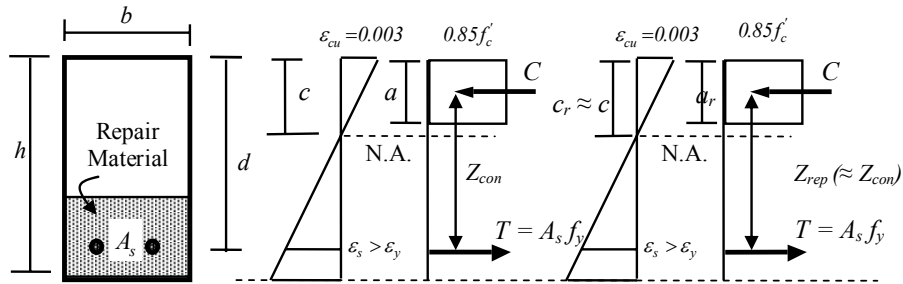
Fig. 11. Stress-strain diagrams for tension side repaired specimens.

It is to be noted that, in the tension side, at an early stage, concrete or repair material has to crack in order to transfer strains to steel through bond. At the ultimate strength stage, stress in tension steel exceeds its yield value and beam reaches its load capacity (i.e. failure stage) when the concrete strain in compression reaches its ultimate value, that is,  $\sim 0.003$  (Fig. 11). Therefore, depending on the strength of the repair material, crack may initiate earlier or later but the load capacity will finally be governed by the bond between the repair material and steel. It is due to this reason, with repair material, that no improvement in load capacity was observed compared to repair with concrete. Further, with repair material, the load capacity values were little less than that of the reference beam because the bond with repair material was a bit less strong than that with concrete in the reference beam.

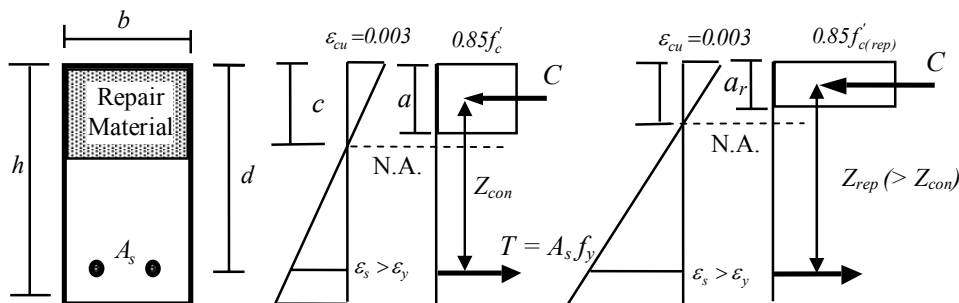
Fig. 12. Stress-strain diagrams for compression side repaired specimens.

All beams repaired in compression showed capacities between 39.5 and 41.5 kN, with gains in load capacity between 12.3% and 17.8% over that of the control beam (35.2 kN). This gain in load capacity can be attributed to the higher compressive strength of repair material. Due to the higher strength on the top side, the net compressive force shifts up, and as a result, the arm of the forces becomes larger. This increase in the lever arm ultimately increases the moment resistance of the beam (Fig. 12) which leads to a higher load capacity for the repaired beam.

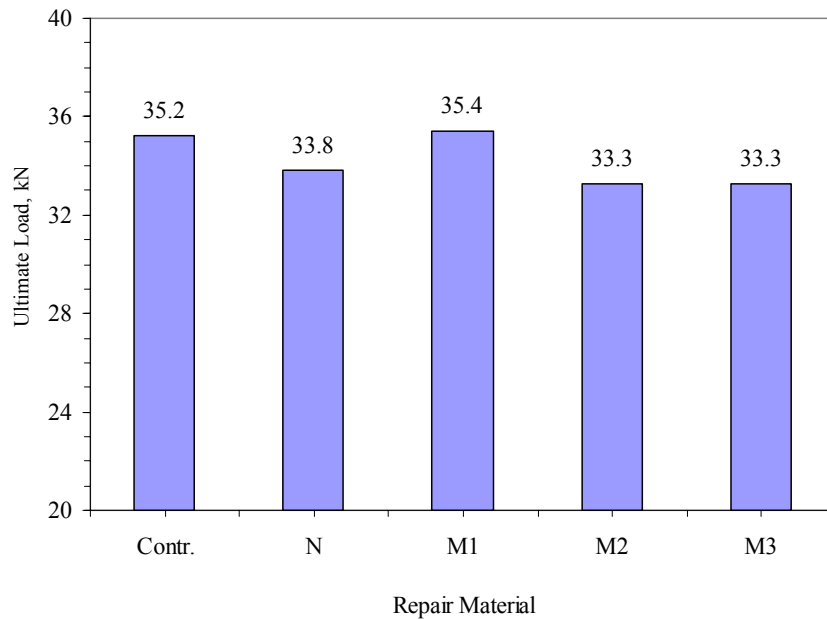
**Fig. 13. Ultimate loads of beams repaired in Tension with M1, M2, M3 and normal concrete compared to the control beam.**

Figure 13 shows this comparison of repair in tension using M1, M2 and M3 with concrete repair (N) and reference (Contr.) beams. The results show that M1, M2 and M3 produced no significant gain in performance compared to that of beam repaired with normal concrete.

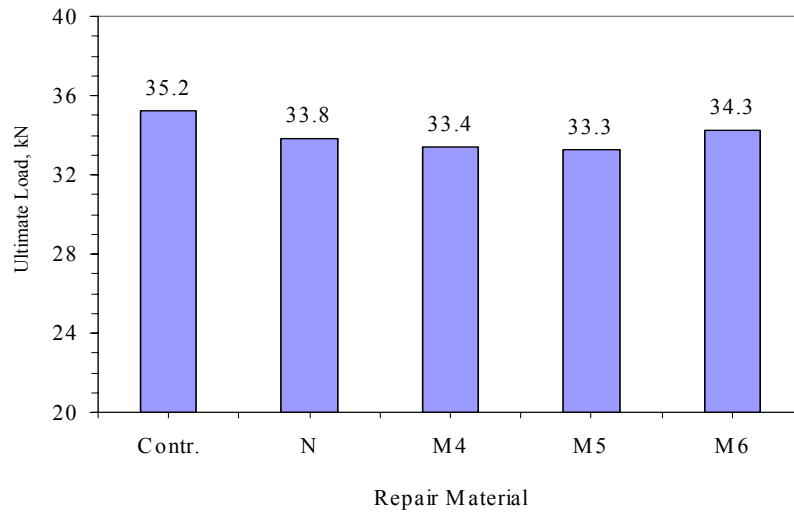
**Fig. 14.** Ultimate loads of beams repaired in *Tension* with M4, M5, M6 and normal concrete compared to the control beam.

Similarly, Fig. 14 shows the performance of the second group M4, M5 and M6 materials. The figure shows that M4, M5 and M6 performed in tension similar to that repaired with concrete and slightly less than the control monolithic beam.

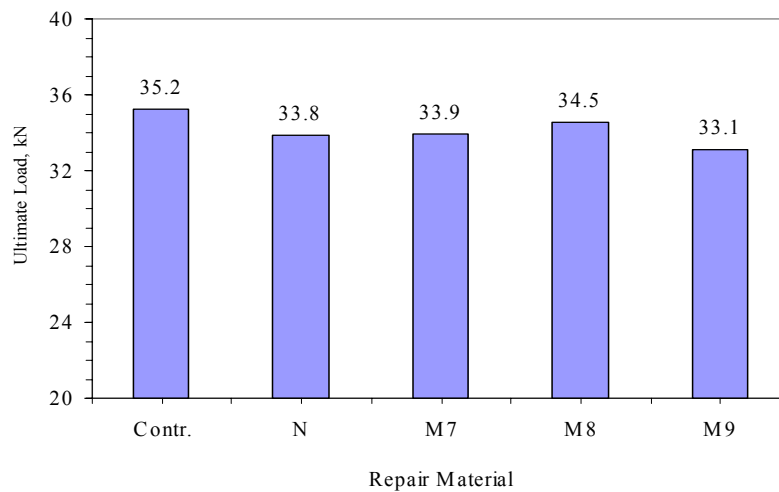
**Fig. 15.** Ultimate loads of beams repaired in *Tension* with M7, M8, M9 and normal concrete compared to the control beam.

Figure 15 shows the performance of the third group M7, M8 and M9 materials in tension. The figure shows that M8 is better than M7 and M9 but less than the control. Also, M7 and M9 have performance almost similar to that of repaired with concrete.

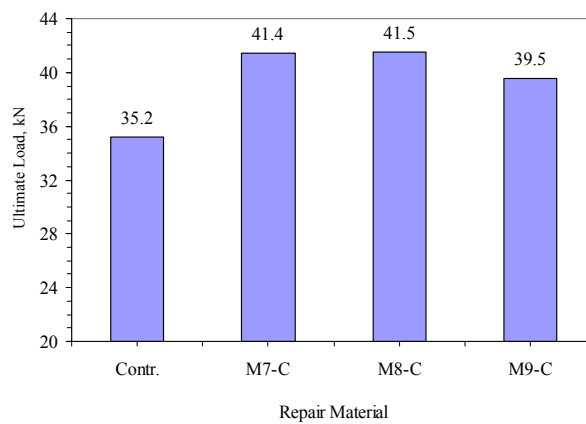
Fig. 16. Ultimate loads of beams repaired in *Compression* with M7, M8, M9 and compared to the control beam.

Figure 16 shows the performance of the third group M7, M8 and M9 materials in compression. Actually all the three materials performed well in compression. The material M8 produced the highest capacity (41.5 kN) compared to 35.2 kN of the control, i.e. an increase by 17.8%.

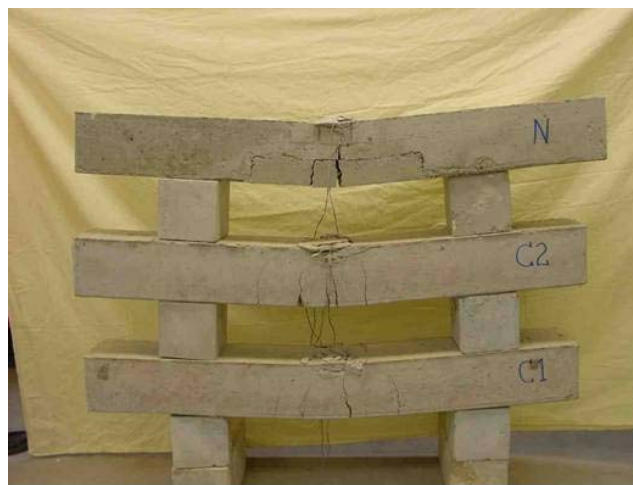
Fig. 17. Control and tension side concrete (N) repaired specimens.

All beams failed by flexure without debonding of the repair materials. Photos of the beams after testing showing typical failures of control and repaired specimens are shown in Figs. 17-19.

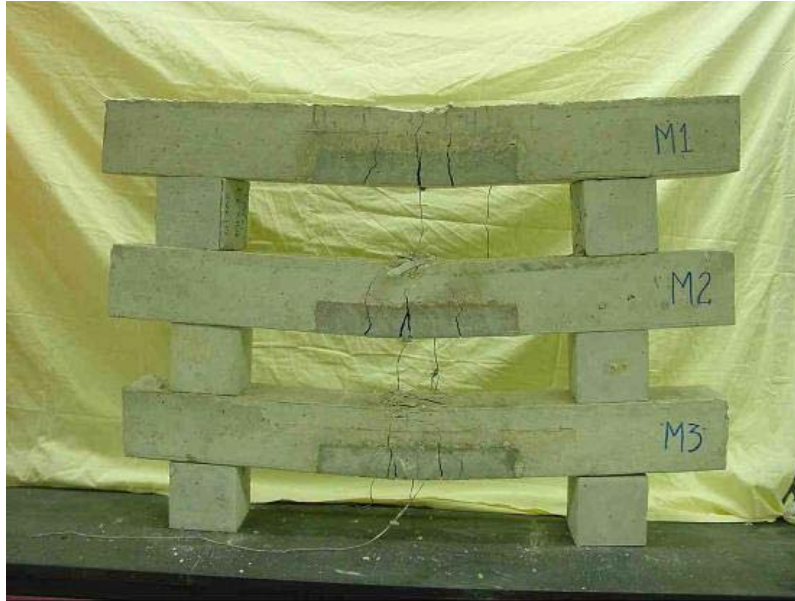
Fig. 18. Beams repaired in *Tension* with M1, M2 and M3 materials.

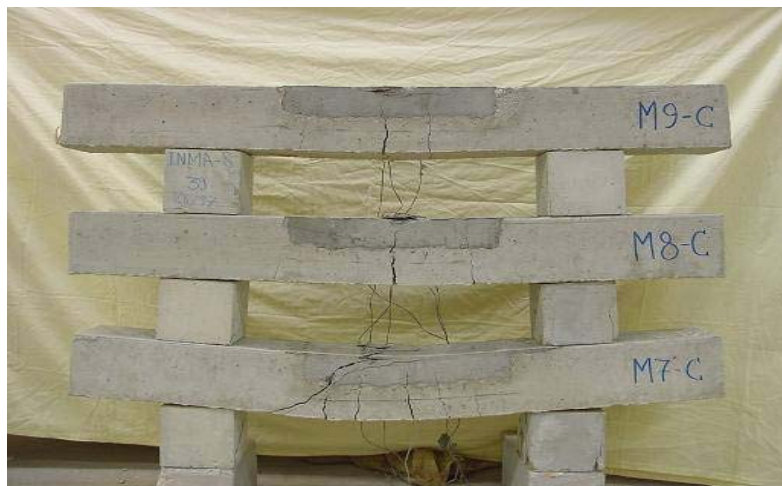
Fig. 19. Beams repaired in *Compression* with M7, M8 and M9 materials.
